5.5 Wind Control Devices with suppression WDF 5

The fifth experiment in the series was conducted to examine the impact of wind on the structure fire and quantify the impact of the small wind control device. It also examined the impact of a 30 gpm water flow to be applied in conjunction with the WCD deployment. The experimental preparations were made as described in Section 4. The fan speed used in this experiment was 1500 RPM, which provided a 3.0 m/s to 4.0 m/s (7 mph to 9 mph) wind speed at the window opening. A trash container fuel package was ignited remotely with an electric match to start the experiment at Time = 0 s. A time line of the experiment is presented in Table 5.5-1. The results for the experiment are presented in the following sections: observations, heat release rate, temperature, heat flux, pressure, velocity, and gas concentrations. An uncertainty range marker is included in each graph.

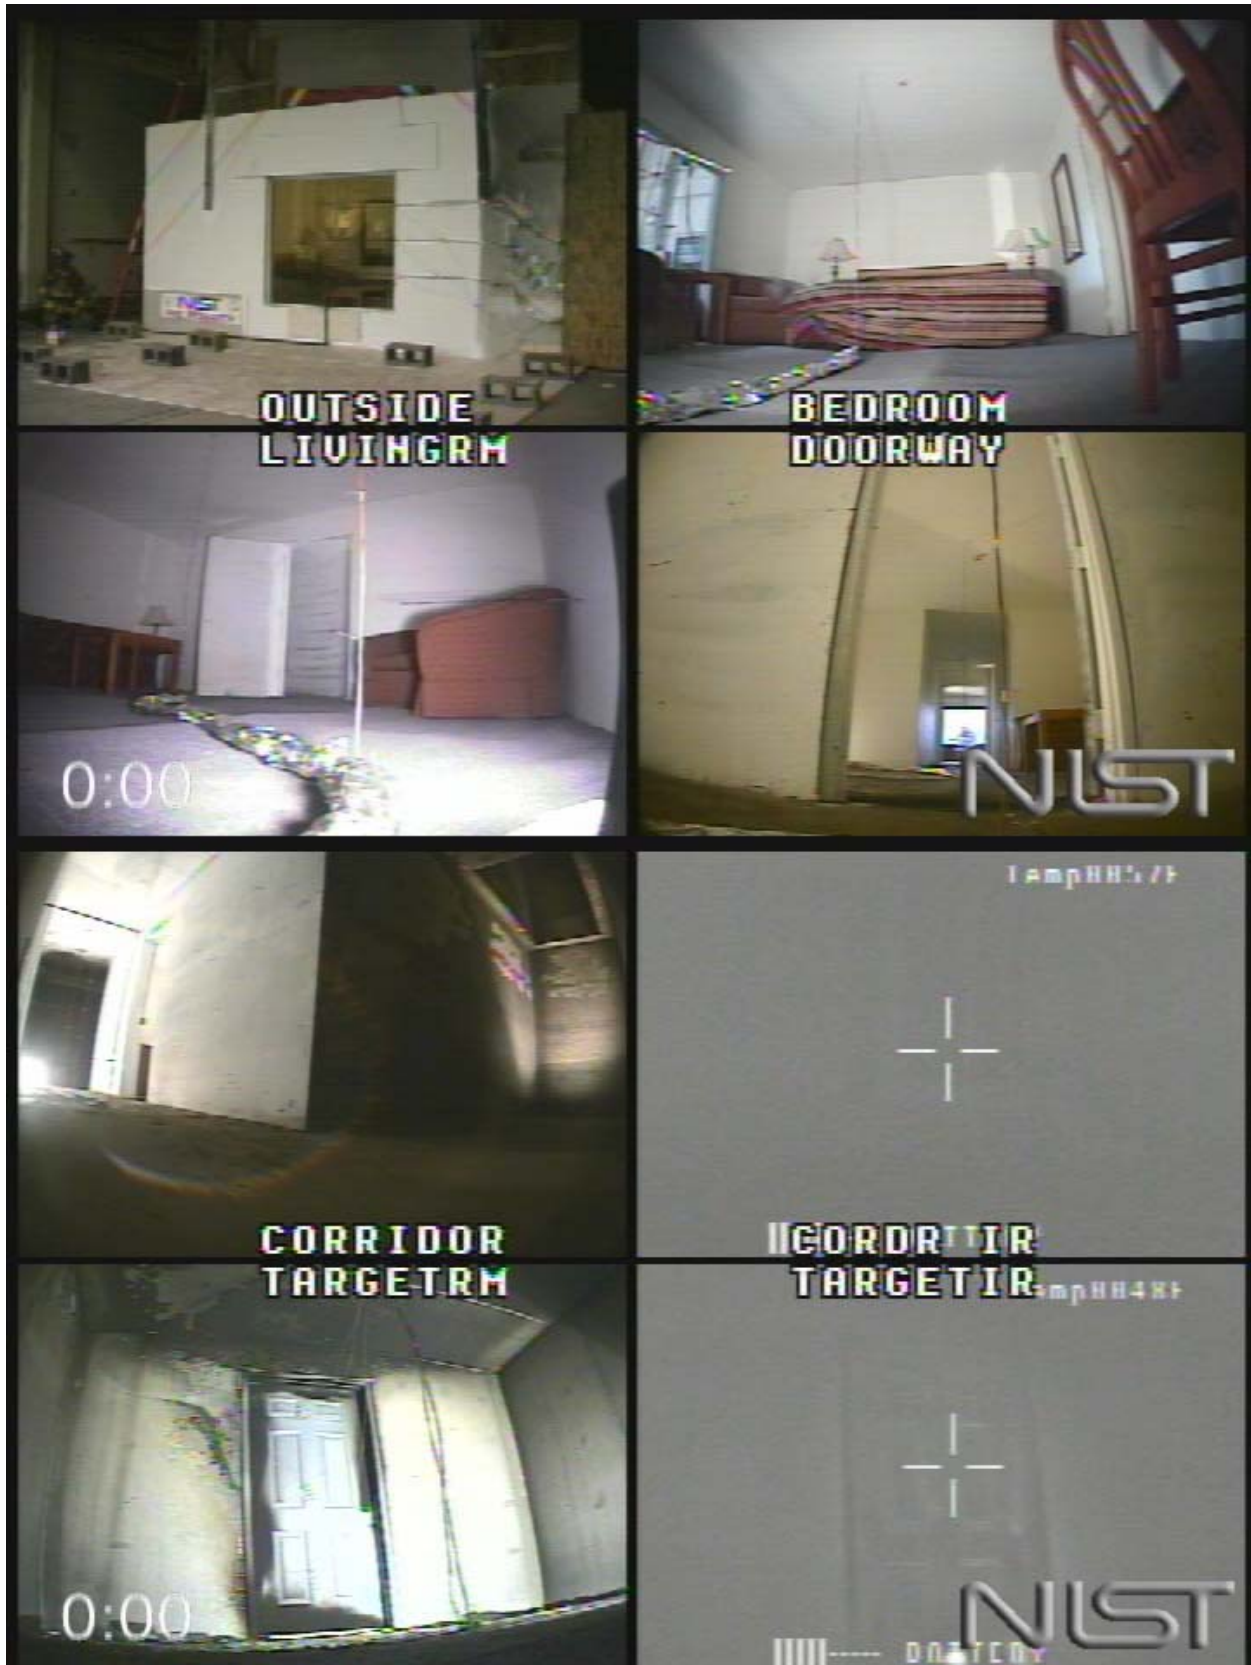
Figure 5.5.1-1. Experiment 5, ignition.

Figure 5.5.1-1 shows the conditions at the time of ignition. At this point, the six video views are clear and unobstructed. However, the thermal images provide limited thermal contrast because the surfaces in the view were at nearly equal temperature.

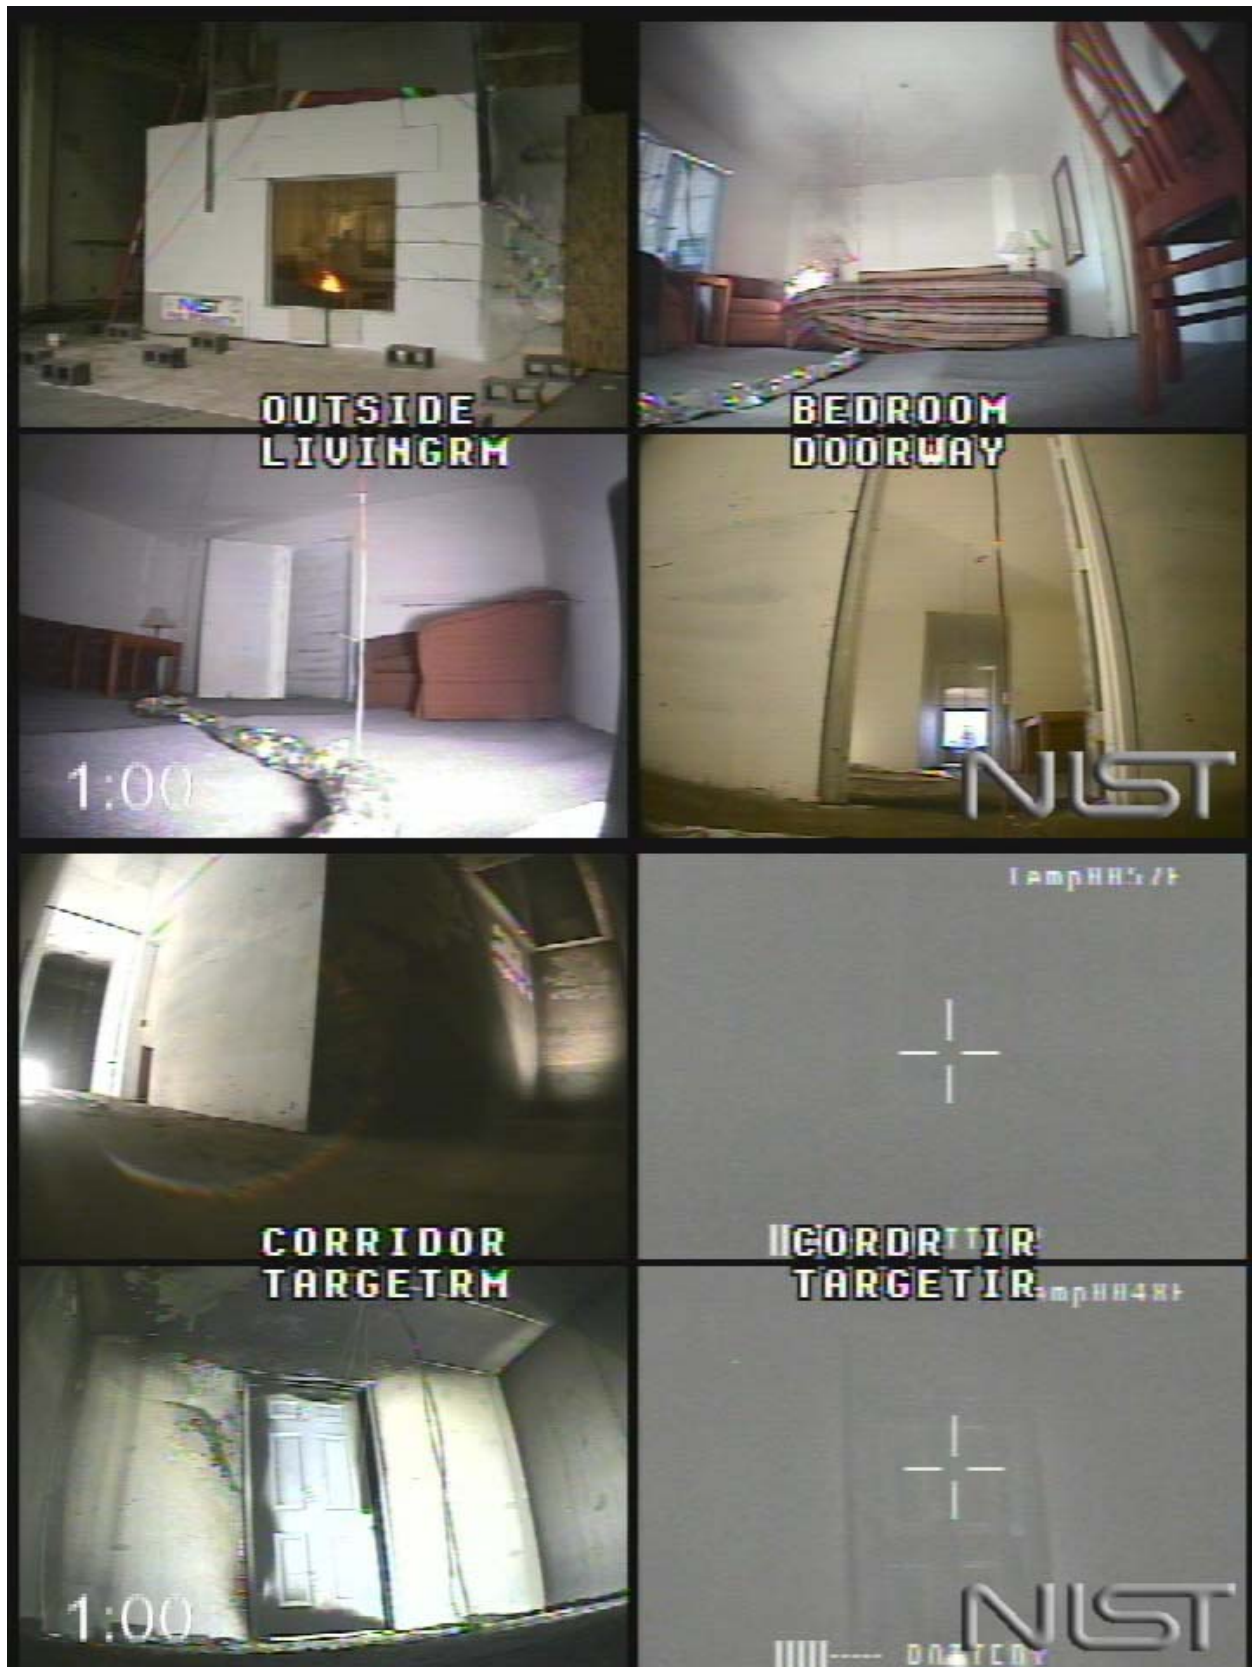
Figure 5.5.1-2. Experiment 5, 60 s after ignition.

The images in Figure 5.5.1-2 were captured 60 s after ignition. The fire from the trash container began to spread to the bed. There was very little smoke being produced and a layer has yet to develop. There was also no smoke or change in thermal condition in the living room, target room or corridor at this time.

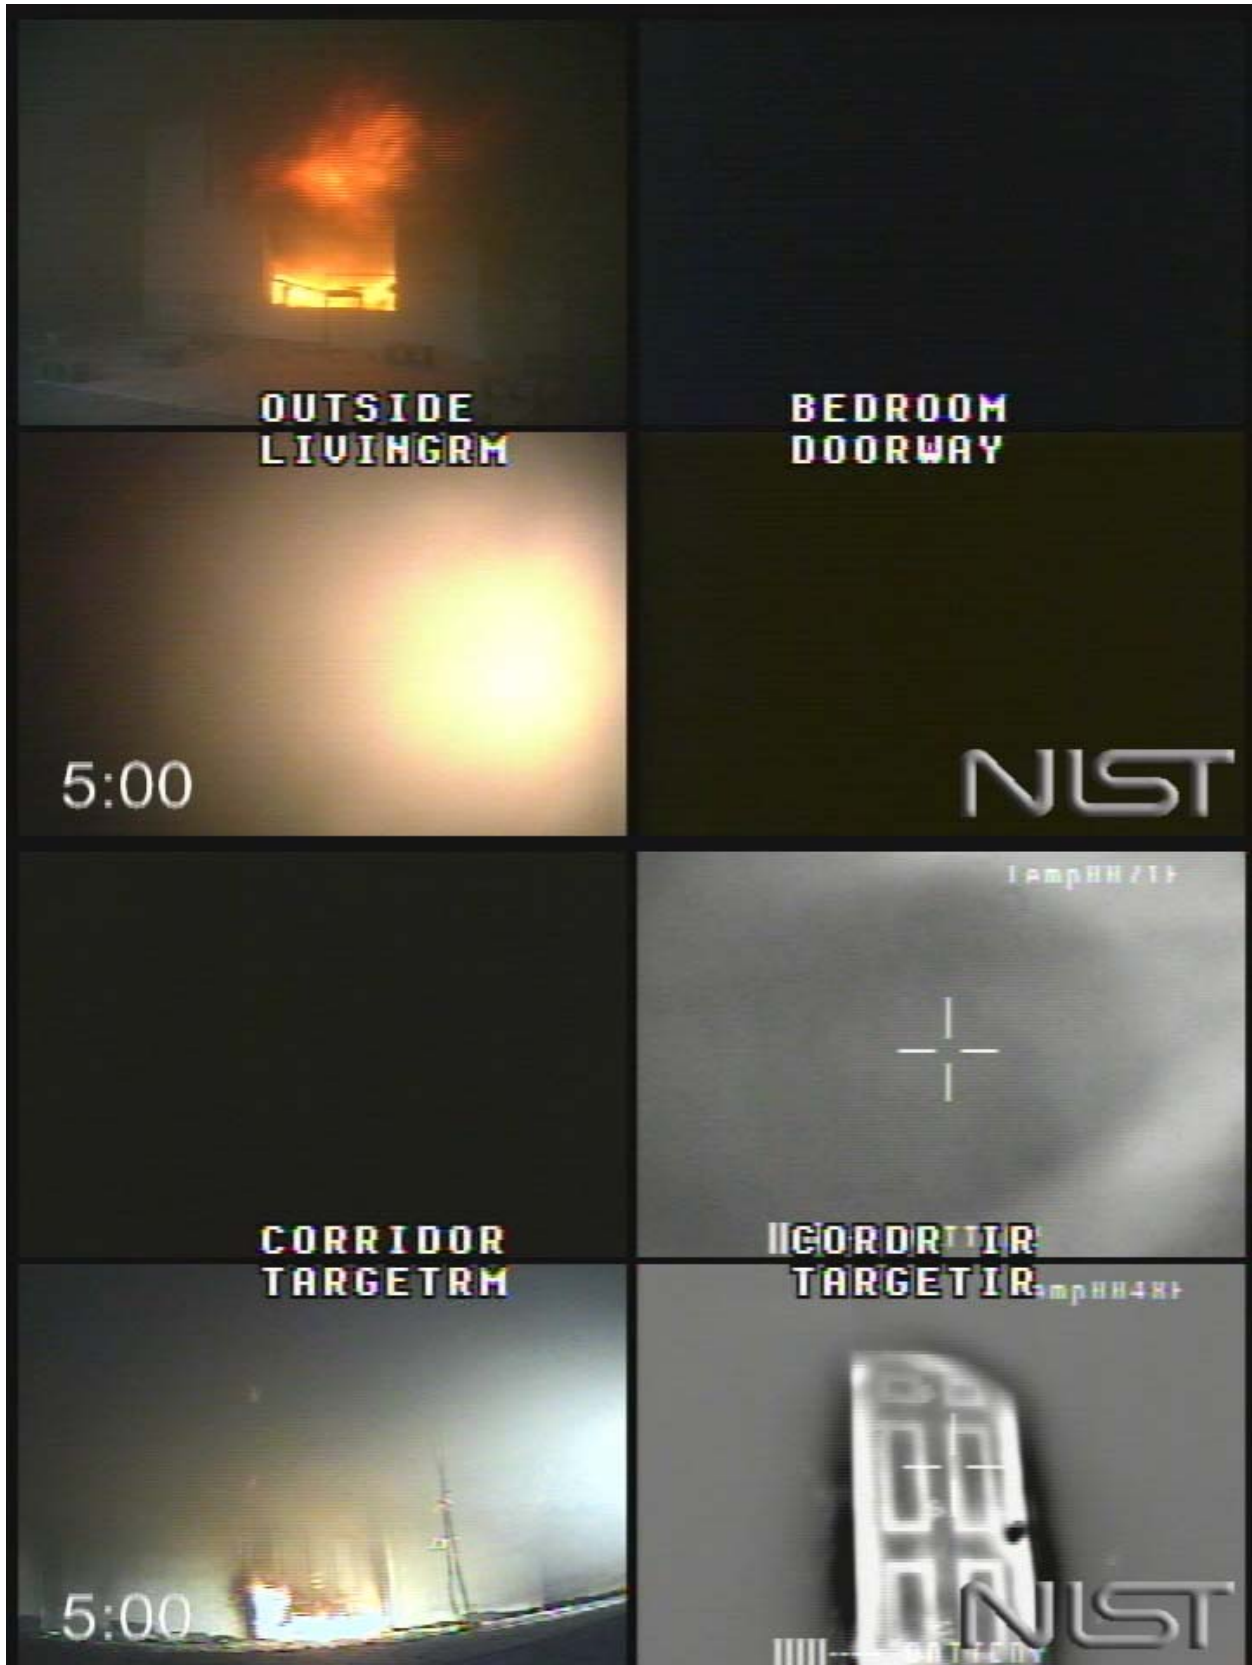
Figure 5.5.1-7. Experiment 5, 300 s after ignition.

Figure 5.5.1-7 shows the conditions at 300 s after ignition. Flames were pulsing out of the top of the window opening. Smoke was obscuring the views in the bedroom, living room and corridor. The amount of heat entering the hallway has caused the image from the corridor IR camera to deteriorate substantially. The visual image in the target room showed flames continuing to burn under the door. The visibility at the lower layer in the target room remained good.

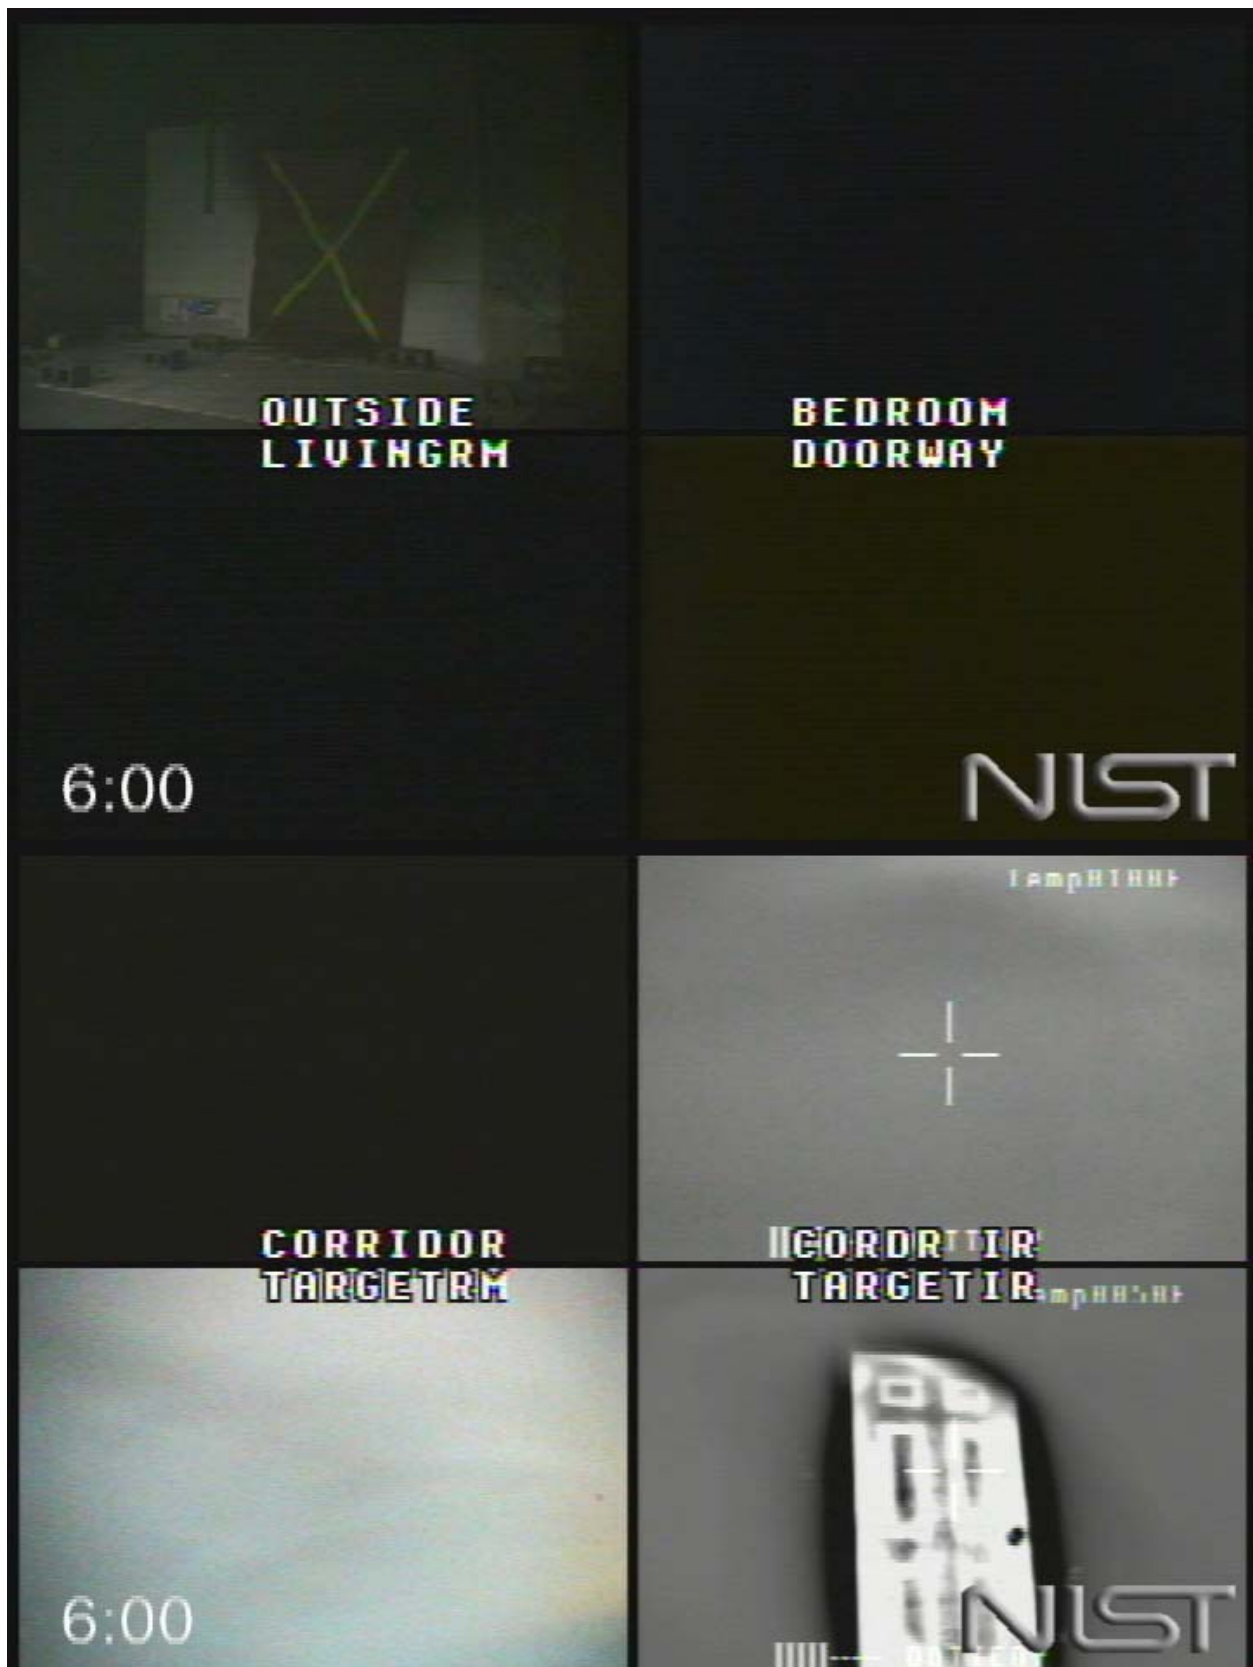
Figure 5.5.1-10. Experiment 5, 360 s after ignition.

Figure 5.5.1-10 shows the conditions at 360 s after ignition, or approximately 30 s since deployment of the wind control device. The interior video views were still obscured by soot. The thermal image from the corridor was still saturated with heat. In the target room the door continued to heat up but remained fully intact. White smoke obscured the view in the target room.

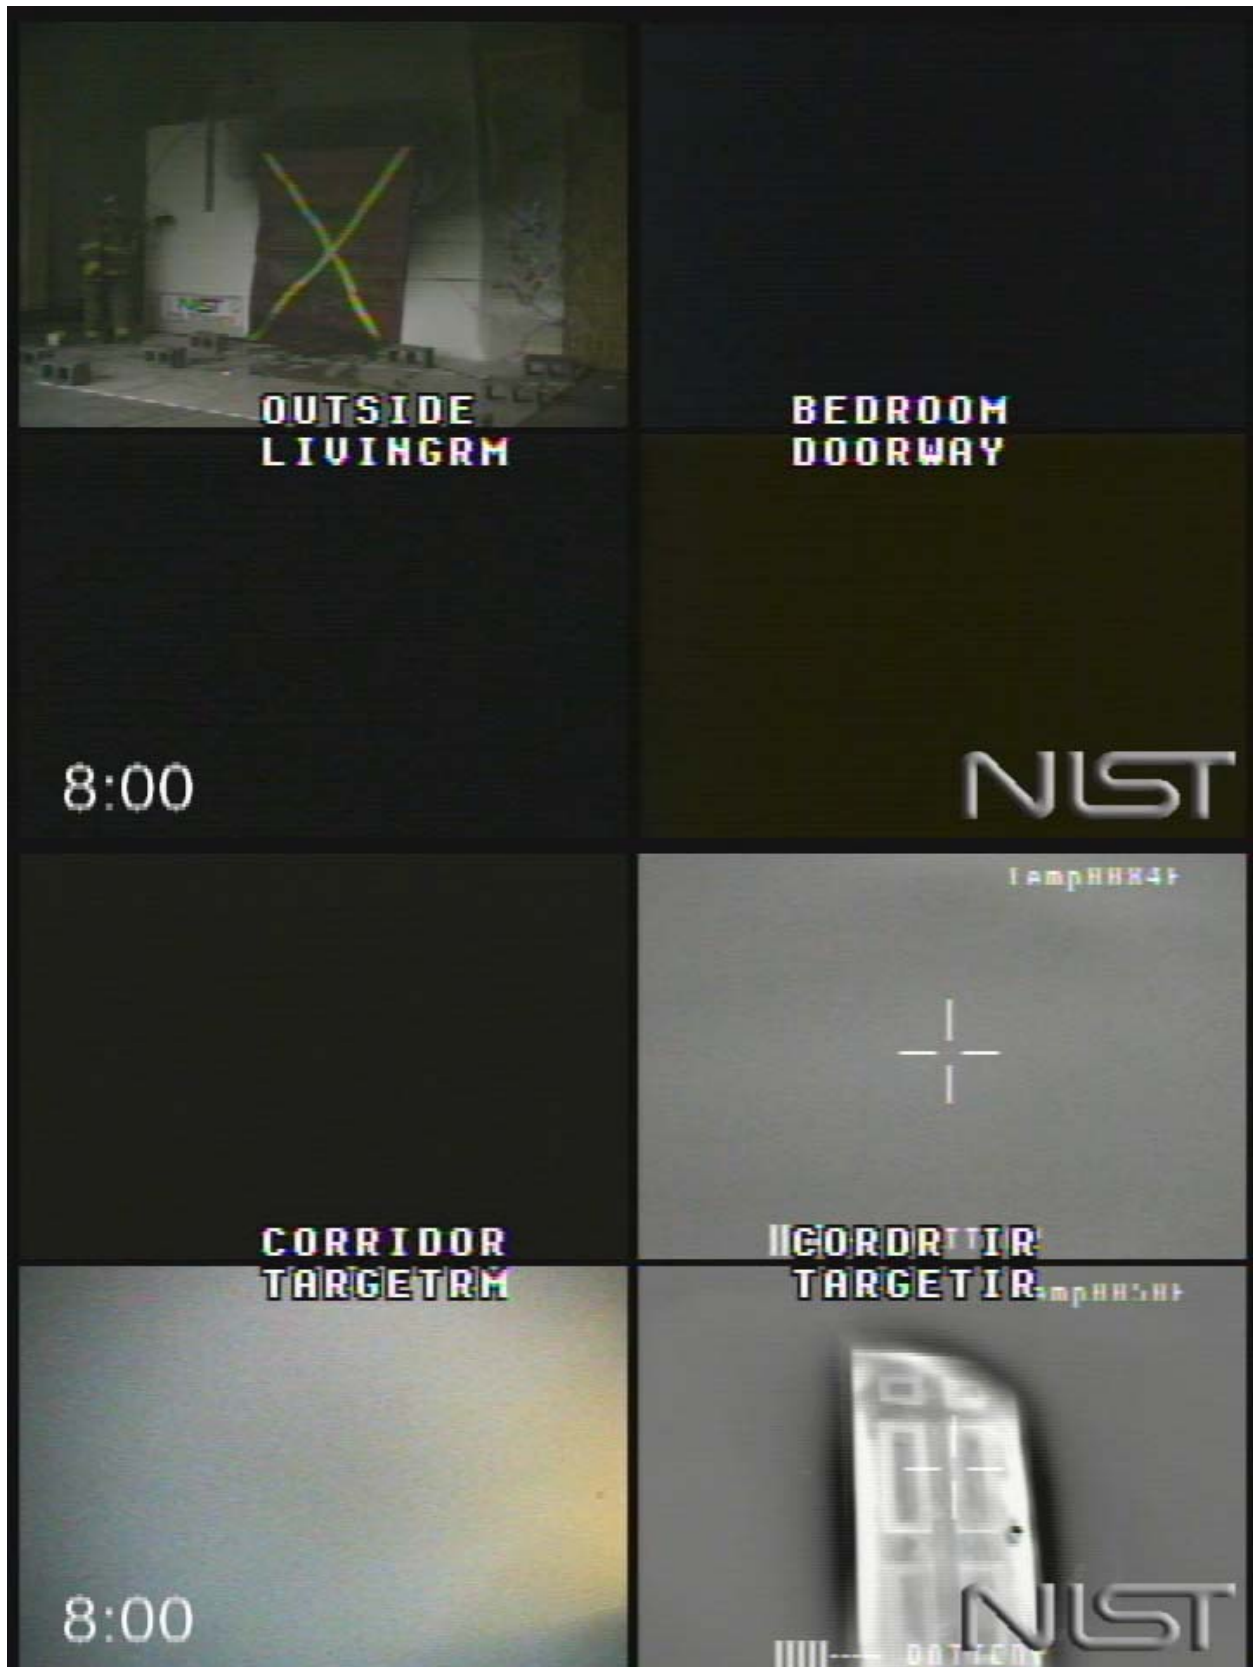
Figure 5.5.1-12. Experiment 5, 480 s after ignition.

The images in Figure 5.5.1-12 were recorded at 480 s after ignition, and 88 s after the window sprinkler was activated. There was very little change in any of the video or thermal images. Figure 5.5.1-13 shows the conditions just after the WCD was removed from the window after the experiment was terminated at 500 s. There were no flames coming out of the bedroom and the fire was knocked down significantly, but not completely extinguished.

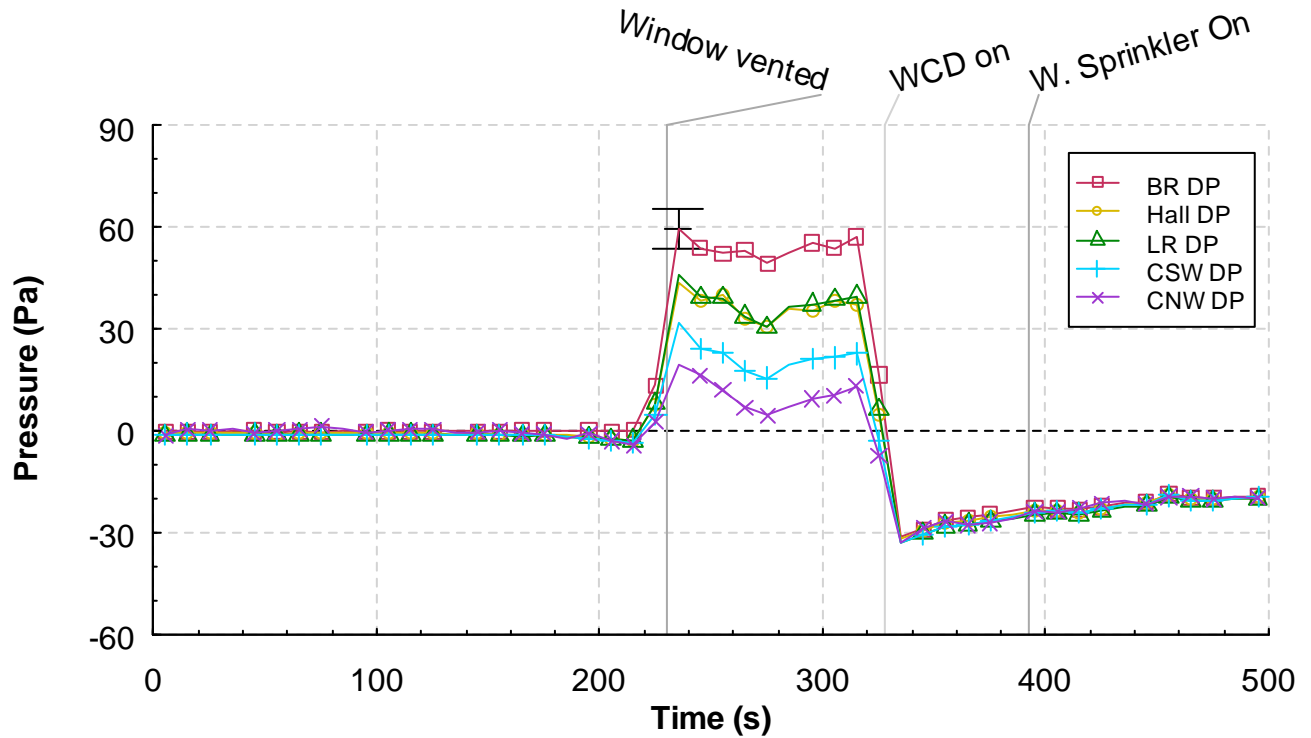
Figure 5.5.5-1. Pressure versus time at five locations, Experiment 5.

Figure 5.5.5-1 shows the pressures at the 5 measurement locations. There was little pressure change in the structure prior to window failure. After window failure the pressures in the structure increased and became fairly steady. The closer to the source of the simulated wind the higher the pressure was. The bedroom pressure increased to an average of 55 Pa, the hallway and living room pressure increased to approximately 35 Pa, the dead end side of the corridor increased to approximately 20 Pa and the vent side of the corridor increased to 10 Pa.

After the WCD was deployed all of the pressures in the structure transitioned to negative. As the pressure stabilized, the pressure in the bedroom decreased to approximately -25 Pa and the pressures decreased to -30 Pa at the vent end of the corridor. While all of the pressures were negative, the gases were still able to flow from a higher pressure (bedroom) to a lower pressure (corridor vent). The magnitude of the negative pressure was created by the flow of hot gases out of the structure and the lack of available make-up air, creating a partial vacuum. The application of water had little to no impact on the pressures, but as the structure cooled the pressures slowly increased.

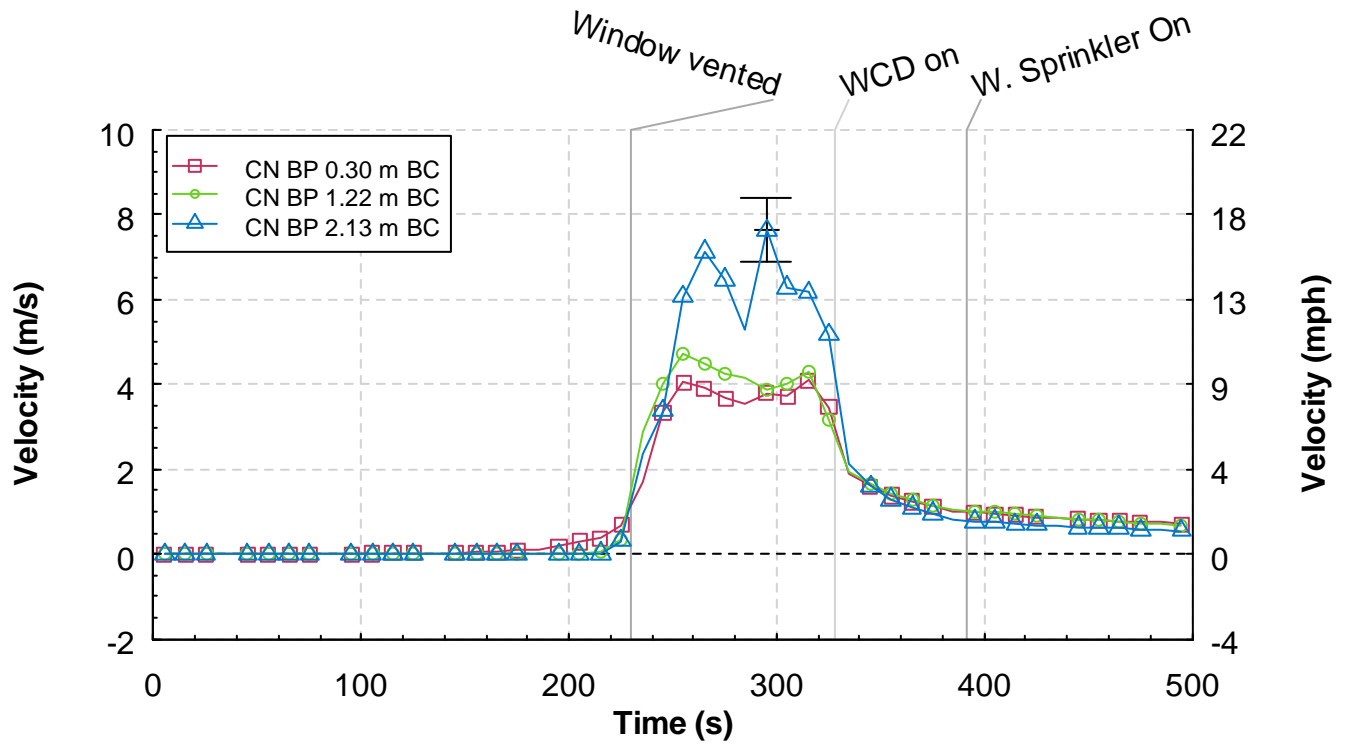
Figure 5.5.6-4. Velocity versus time from the corridor north (CN) bi-directional probe array, Experiment 5.

The velocities from the north corridor position are shown in Figure 5.5.6-4. The positive flow direction for this location is from south to north. Prior to window failure, the ceiling jet/hot gas layer velocities reached a peak of approximately 0.6 m/s (1.4 mph) at 0.3 m (1 ft) below the ceiling. After the window vented the velocities increased to a peak of approximately 7 m/s (15.7 mph) and a range of 3.5 m/s to 7.5 m/s. The velocities decreased to a range of 1 m/s to 2 m/s after WCD deployment and nozzle activation.

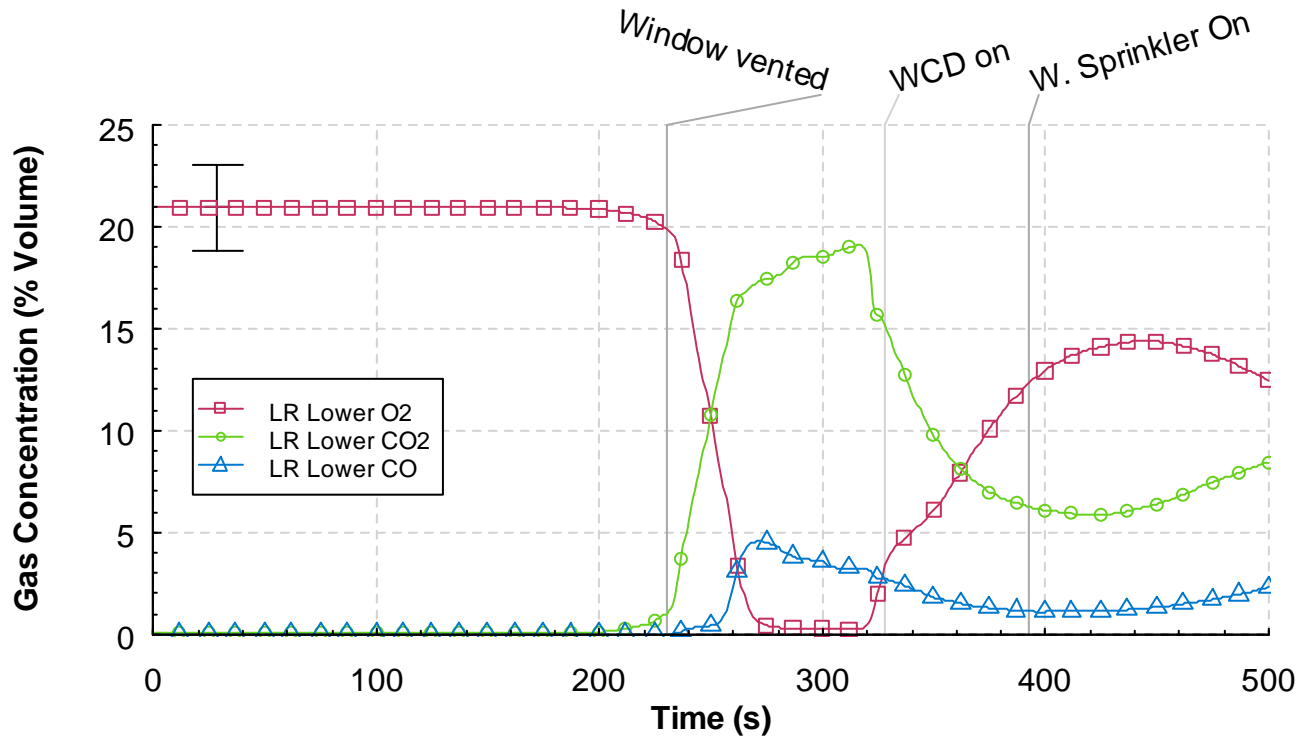
Figure 5.5.7-3. Oxygen, carbon dioxide, and carbon monoxide percent volume versus time from the lower living room (LR) sampling location, Experiment 5.

Figure 5.5.7-2 and Figure 5.5.7-3 provide the measurements from the upper and lower gas sampling probes, respectively, in the living room. The magnitudes and trends of the living room gas concentrations are very similar to those of the bedroom. One main difference is a smaller impact when air was introduced by the failing of the window. Much of the oxygen entering the window was consumed by the fire in the bedroom and it did not make it to the living room. The oxygen concentration in the living room at the top and bottom probed dropped to 1 % before deploying the WCD. The CO₂ reached as high as 19 % and the CO readings peaked at 4 % prior to WCD deployment and 7 % afterwards.

Figure 5.5.7-3 also includes the total hydrocarbon readings from the upper gas sampling probe in the living room. The total hydrocarbon readings begin to increase at about the same time as the CO readings but continue to increase to a peak of 13 % with the WCD in place and the oxygen concentration at a minimum. The concentration decreases after the activation of the low flow nozzle.

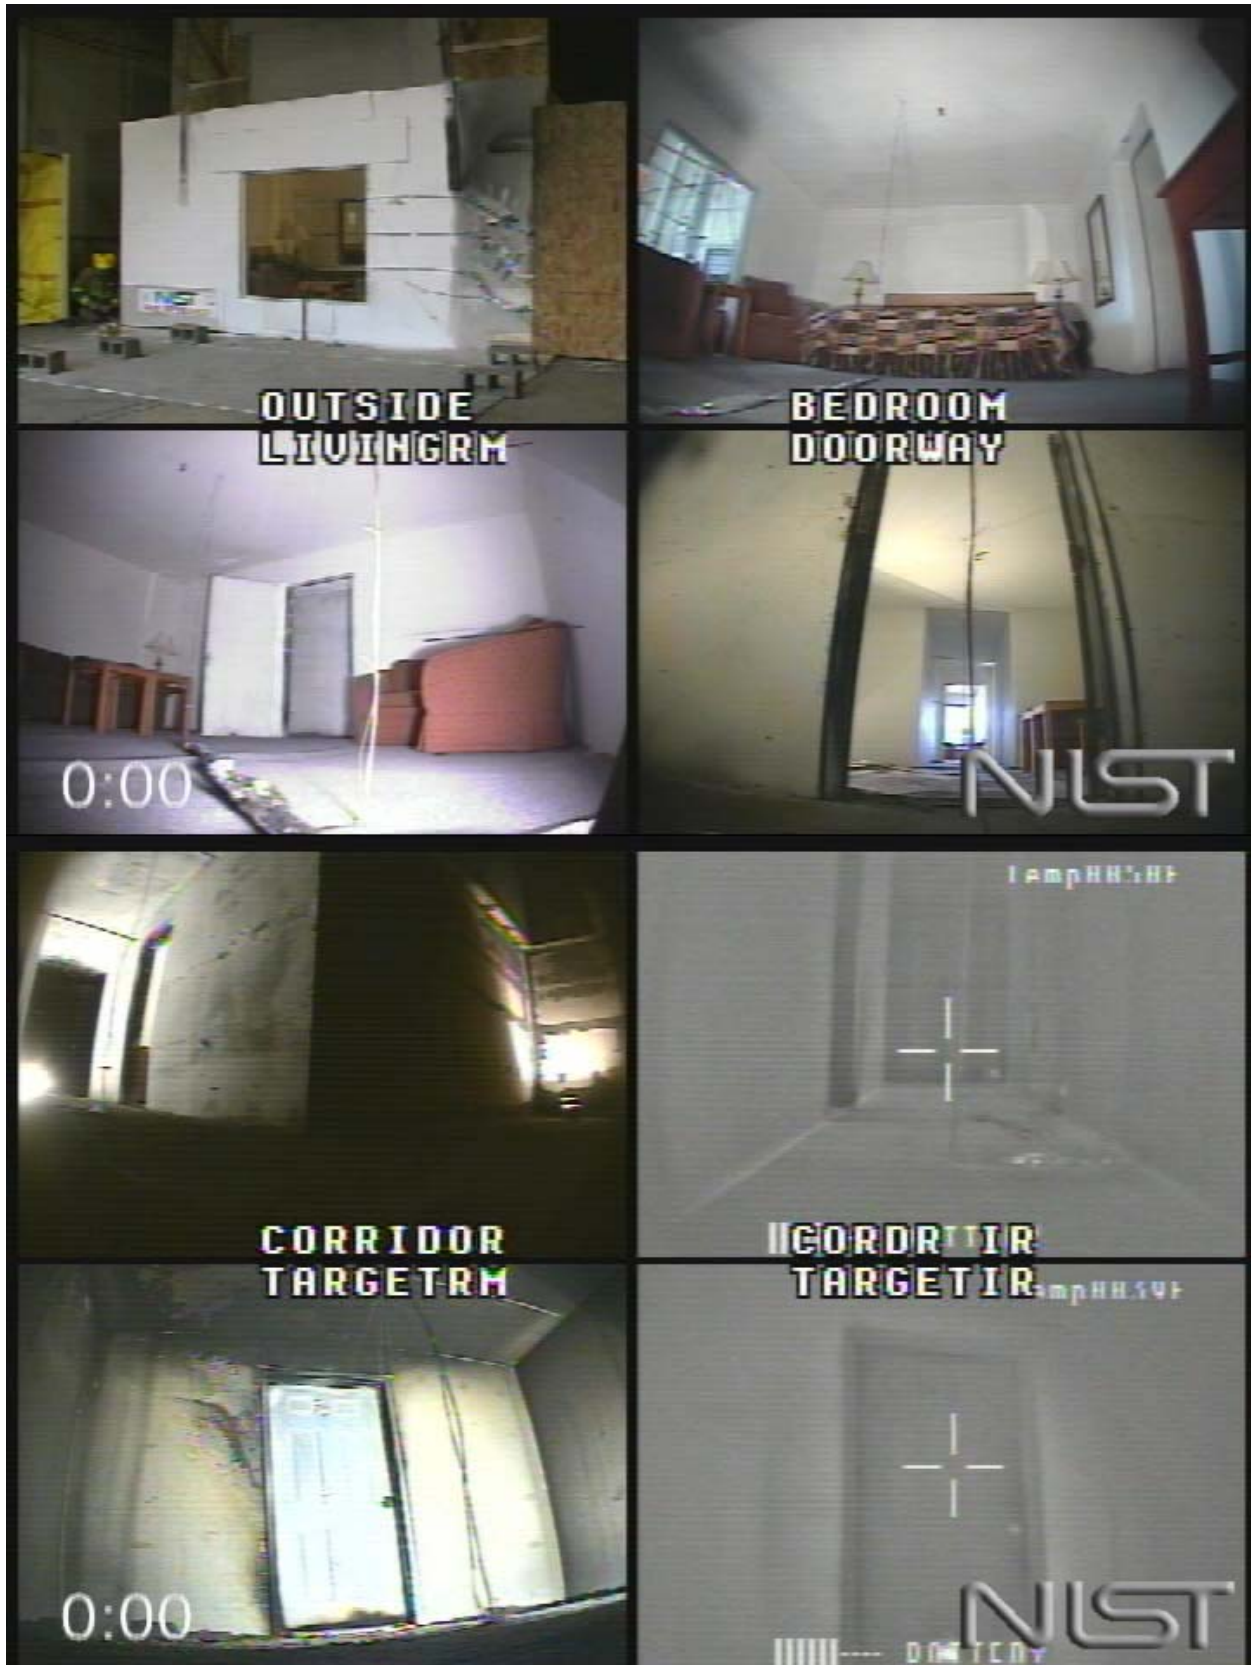
Figure 5.6.1-1. Experiment 6, ignition.

Figure 5.6.1-1 shows the conditions at the time of ignition. At this point, the six video views are clear and unobstructed. However, the thermal images provide limited thermal contrast, because the surfaces in the view were at nearly equal temperature.

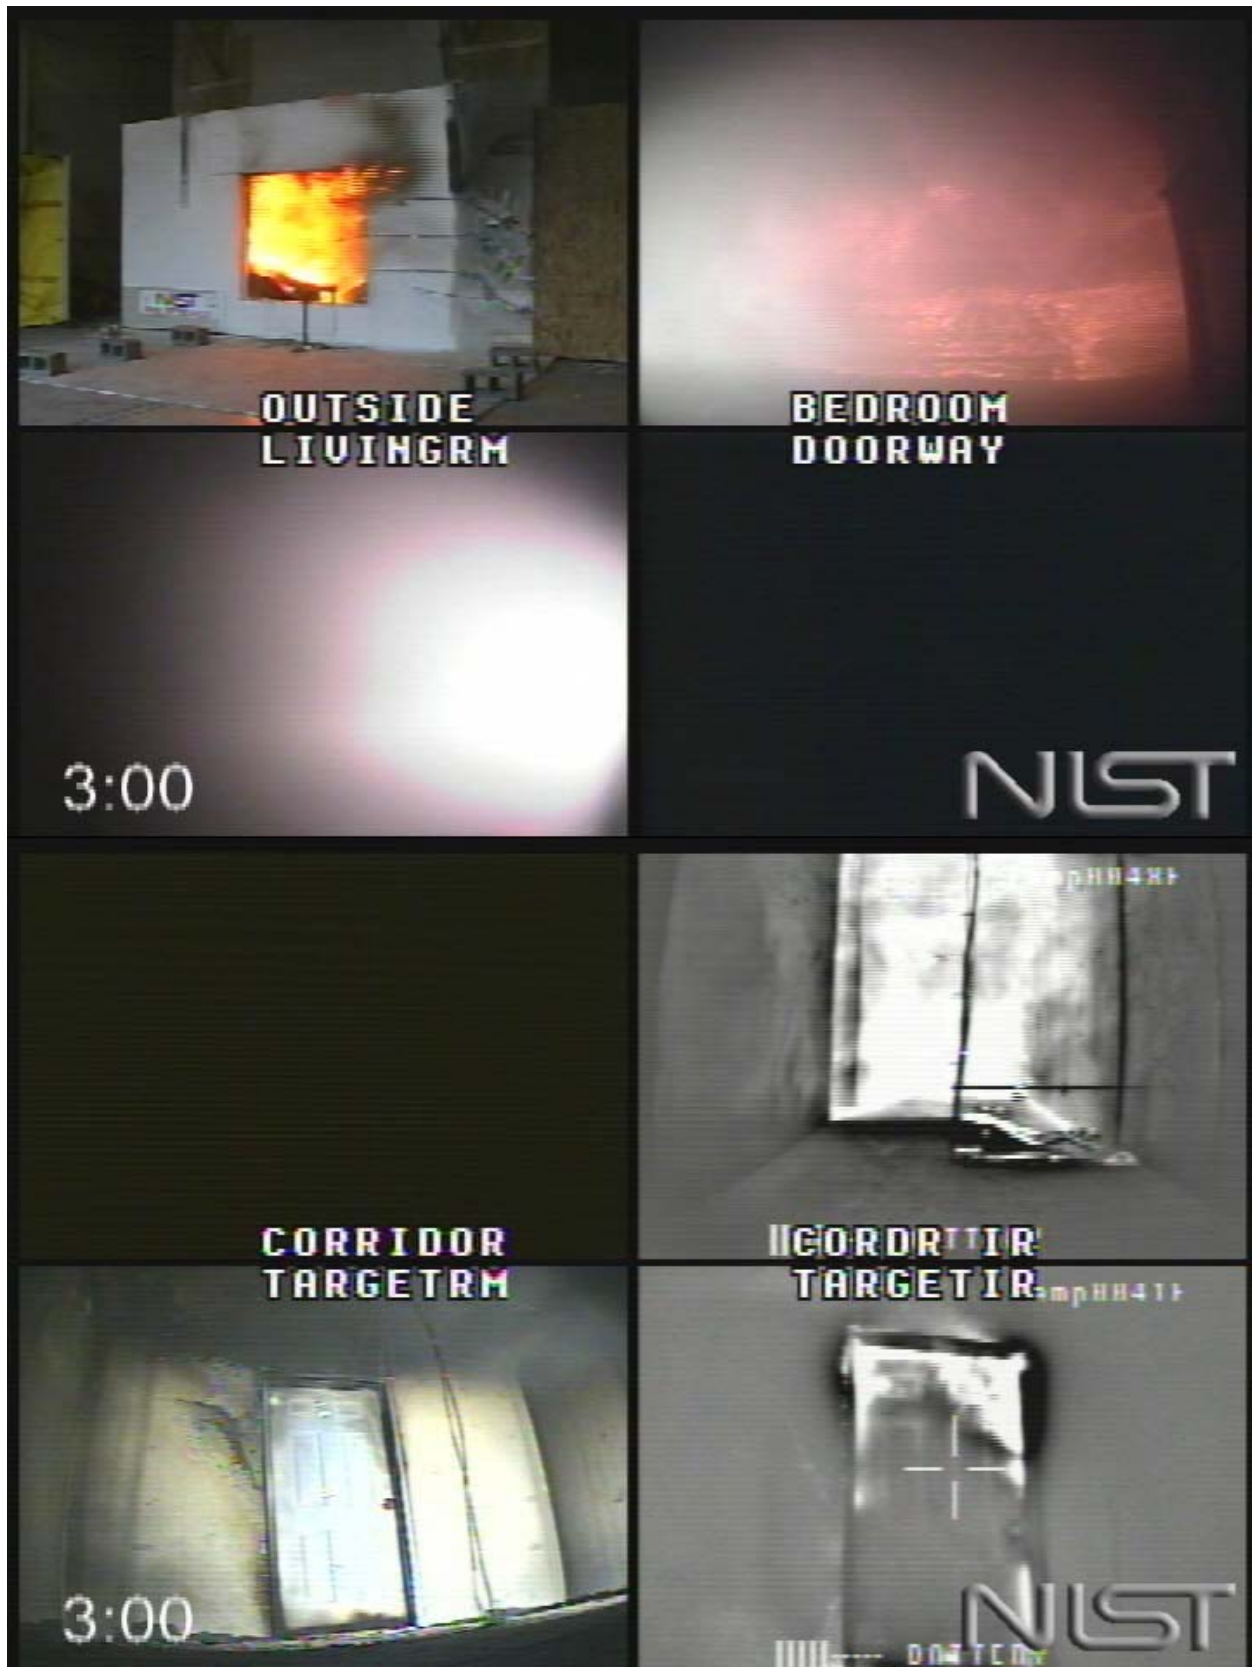
Figure 5.6.1-5. Experiment 6, 180 s after ignition.

Figure 5.6.1-5 shows the conditions at 180 s after ignition. Flames are seen filing the bedroom and moving across the floor level. The camera views in the living room, hallway and corridor are still obscured by smoke. Conditions in the image from the corridor IR camera and the target room views have not changed much since the previous figure.

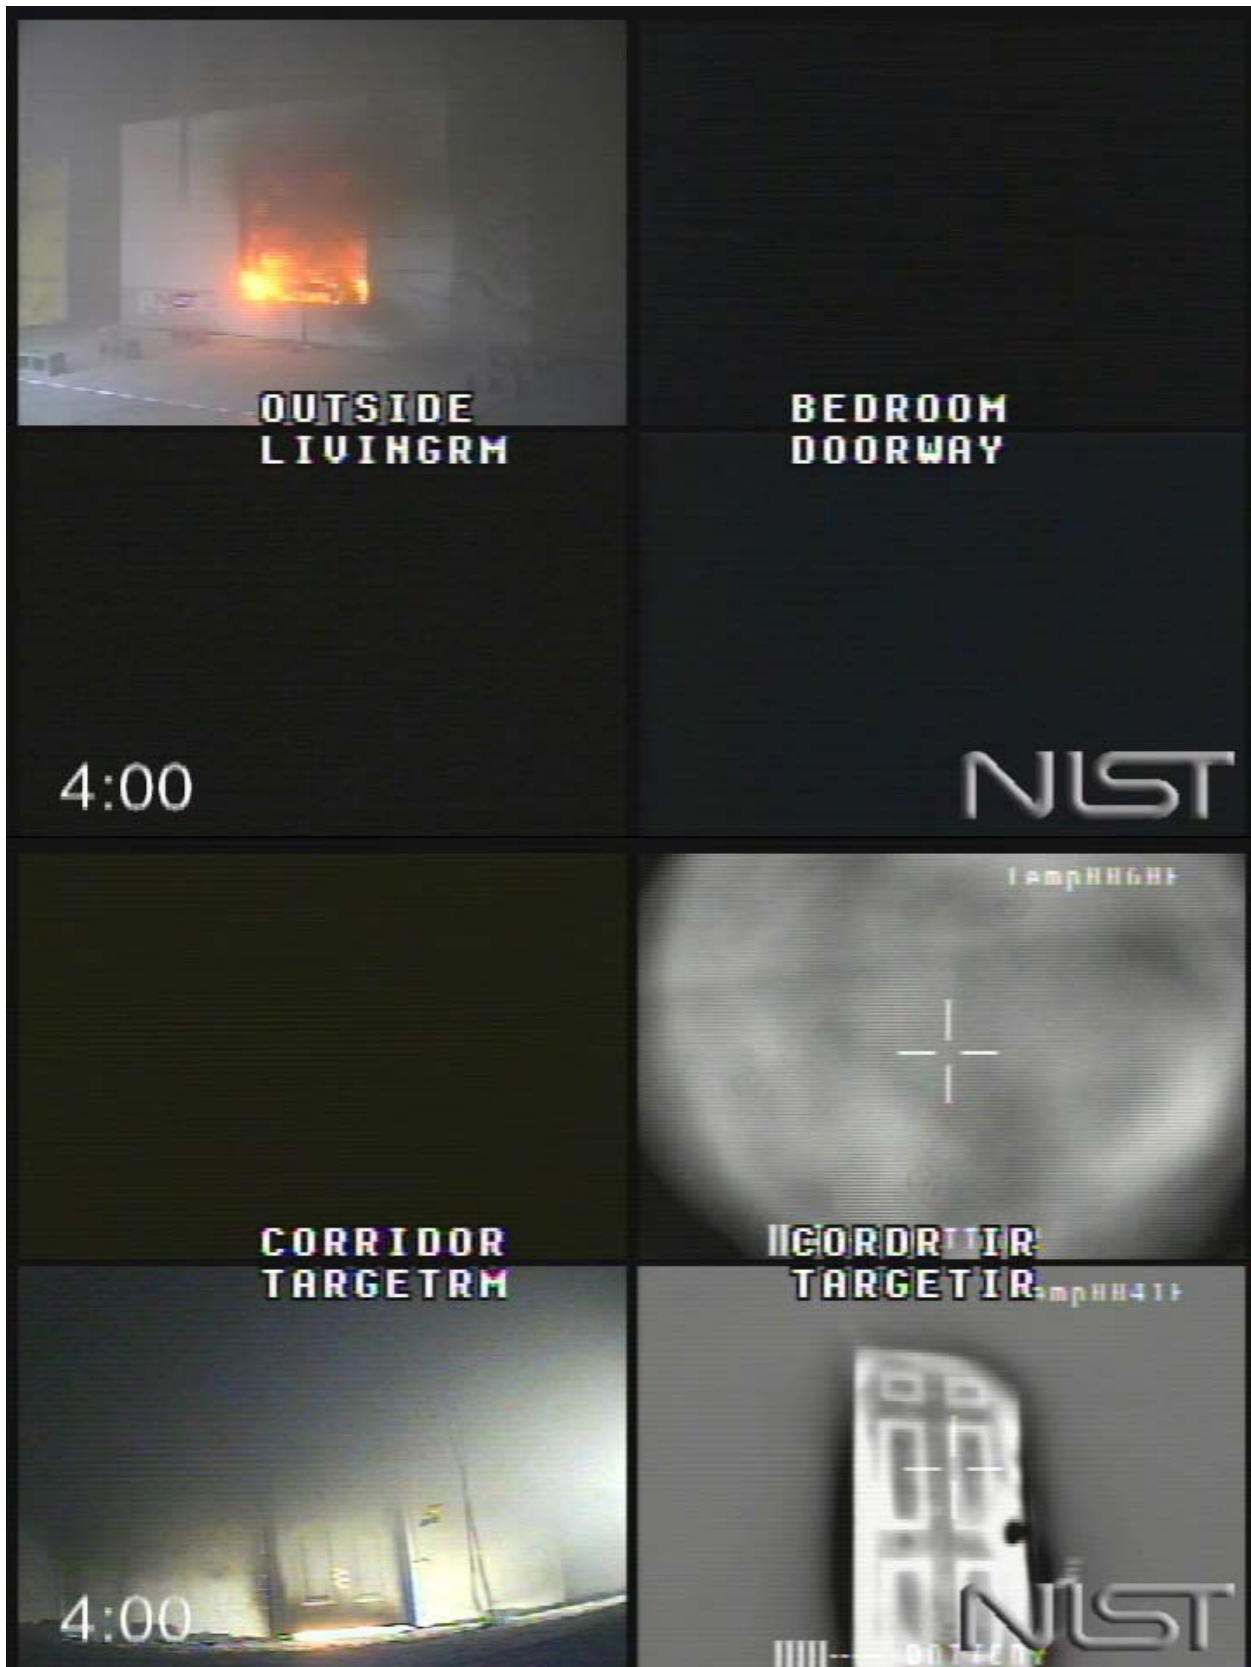
Figure 5.6.1-6. Experiment 6, corridor flames, 192 s after ignition.
